**PRELIMINARY ASSESSMENT/  
VISUAL SITE INSPECTION**

**ACE BATTERY, INC.  
INDIANAPOLIS, INDIANA  
IND 016 389 546**

**FINAL REPORT**

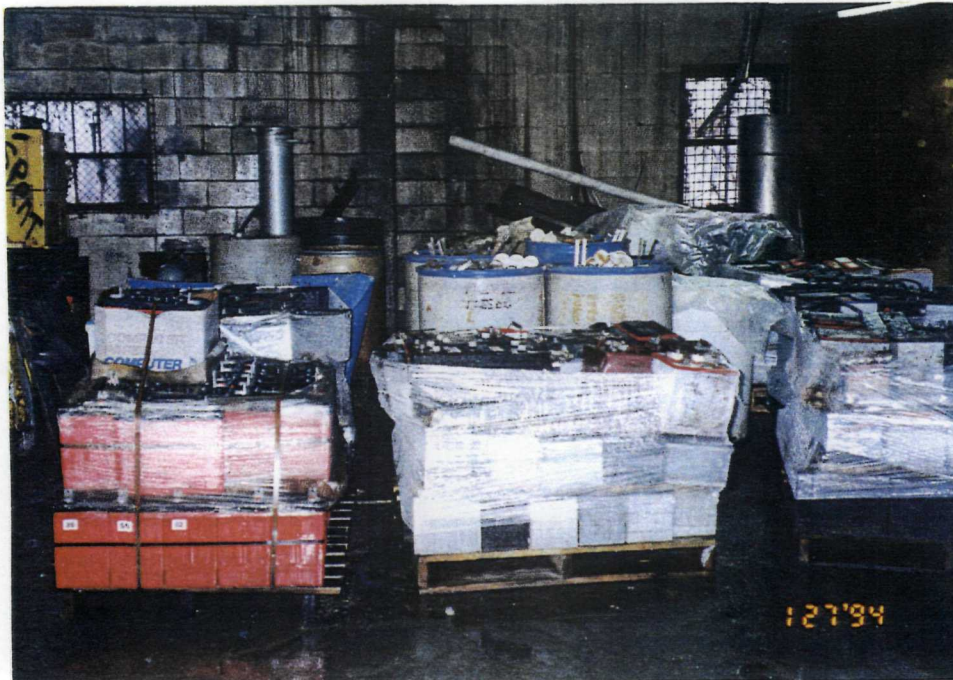
Location: SWMU 1  
 Date: 01/27/94

PRC observed batteries being unloaded during the VSI. The staging area contained about 6 pallets of automobile and miscellaneous batteries and about 17 pallets of large industrial batteries. The concrete floor showed no signs of structural cracking, and all batteries were contained on pallets or in drums. The VSI was conducted during rainy weather, and several areas of the building roof were

Photograph No. 1  
 Orientation: North  
 Description: Staging area for nonindustrial batteries near Unloading Dock

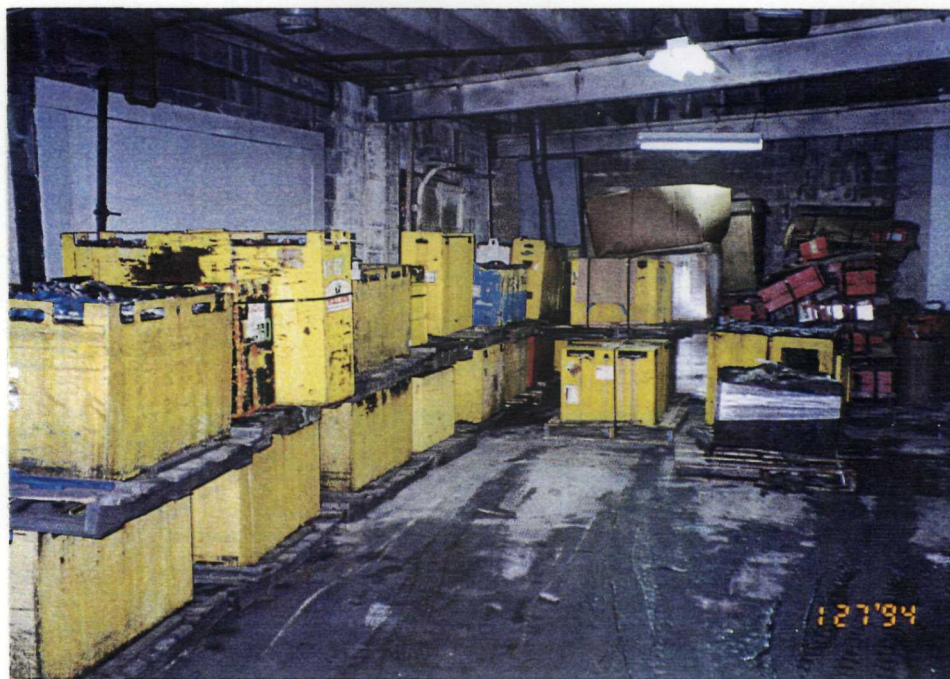
Location: SWMU 1  
 Date: 01/27/94

Photograph No. 2  
 Orientation: West  
 Description: Industrial battery staging area near Unloading Dock

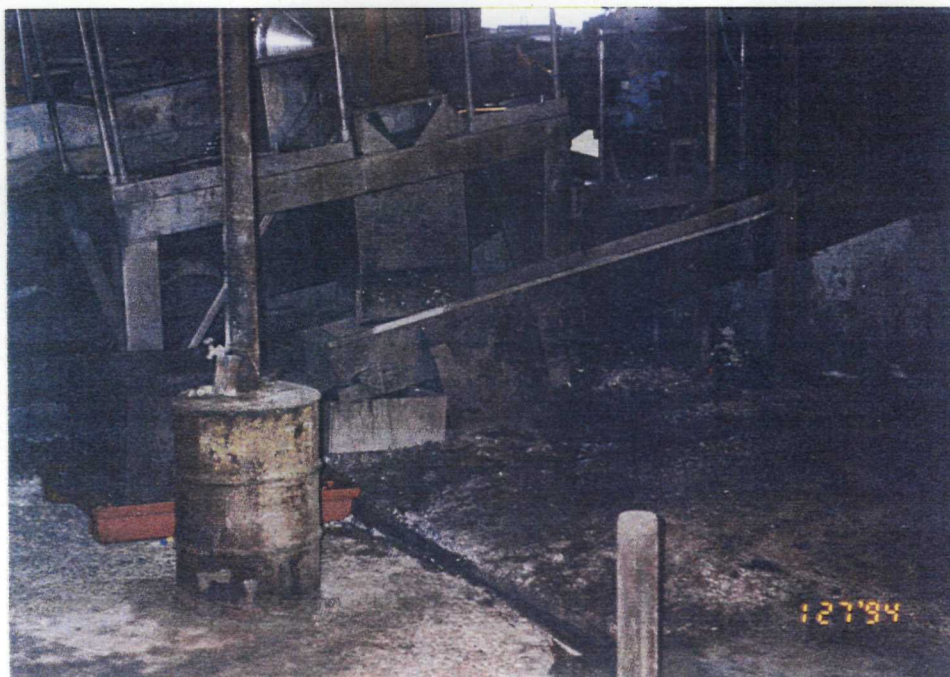
Location: SWMU 2  
Date: 01/27/94

Photograph No. 4  
Orientation: South  
Description: Secondary conveyor and saw assembly

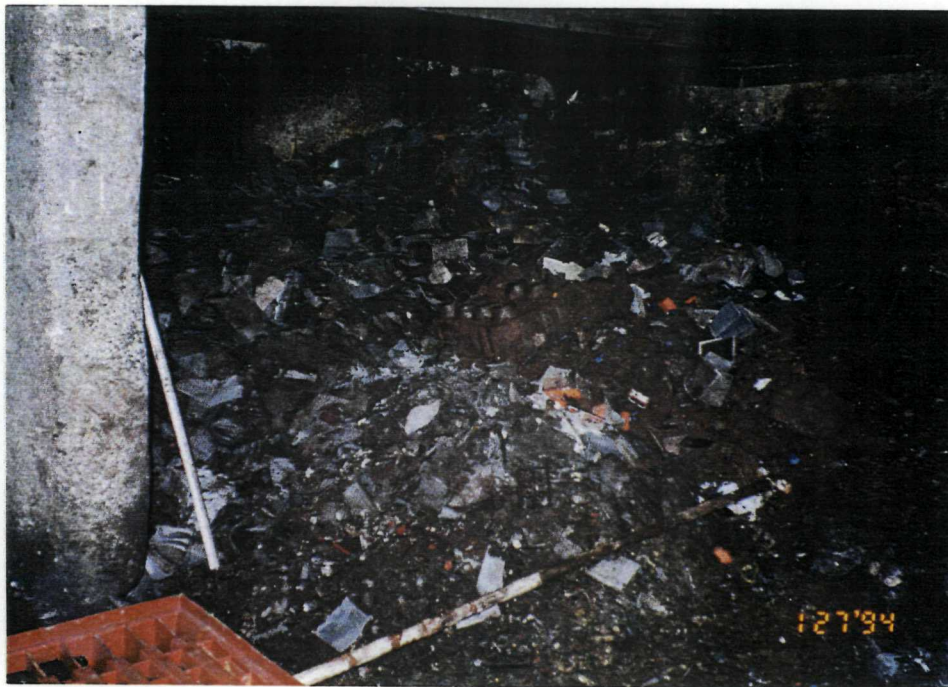
Location: SWMU 3  
Date: 01/27/94

This unit was not operating during the VSI because of frozen wash water in the MA Separator (SWMU 6). The unit did contain an undetermined amount of lead plates and appeared to be about one-quarter full. The concrete floor was free of visible cracks and was wet from roof leakage. ACE reported the concrete to be 8 inches thick in this area and throughout the process building. PRC noted no evidence of release at this unit. Photograph No. 5 shows the lead plates as they are discharged from the tumbler at SWMU 2.

Photograph No. 5  
Orientation: Southeast  
Description: Lead group pile located beneath the Tumbler

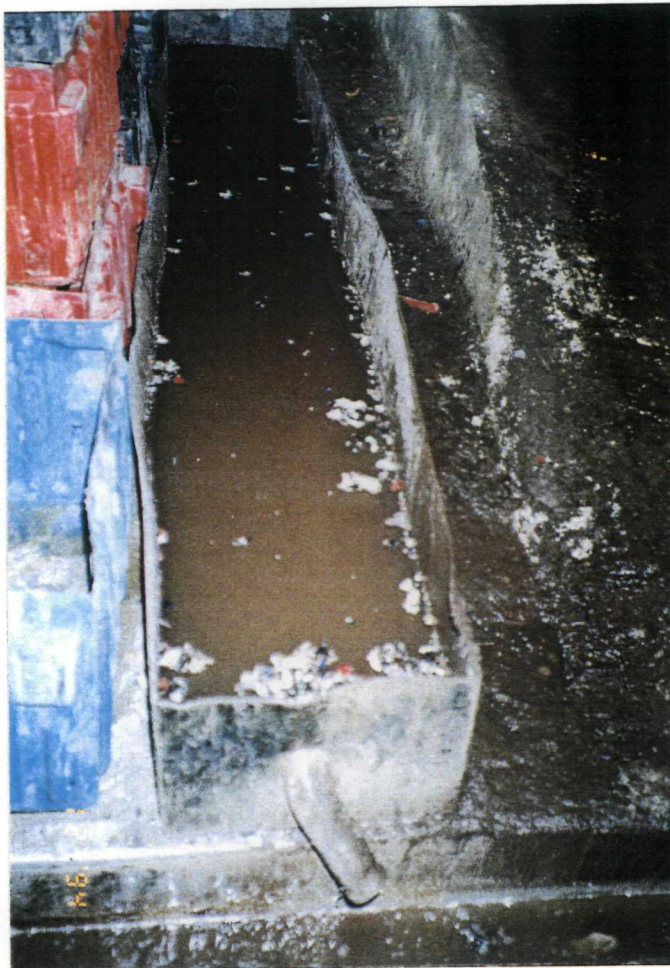
Location: SWMU 4  
Date: 01/27/94

Photograph No. 7  
Orientation: South  
Description: Collection trough along west side of Tumbler

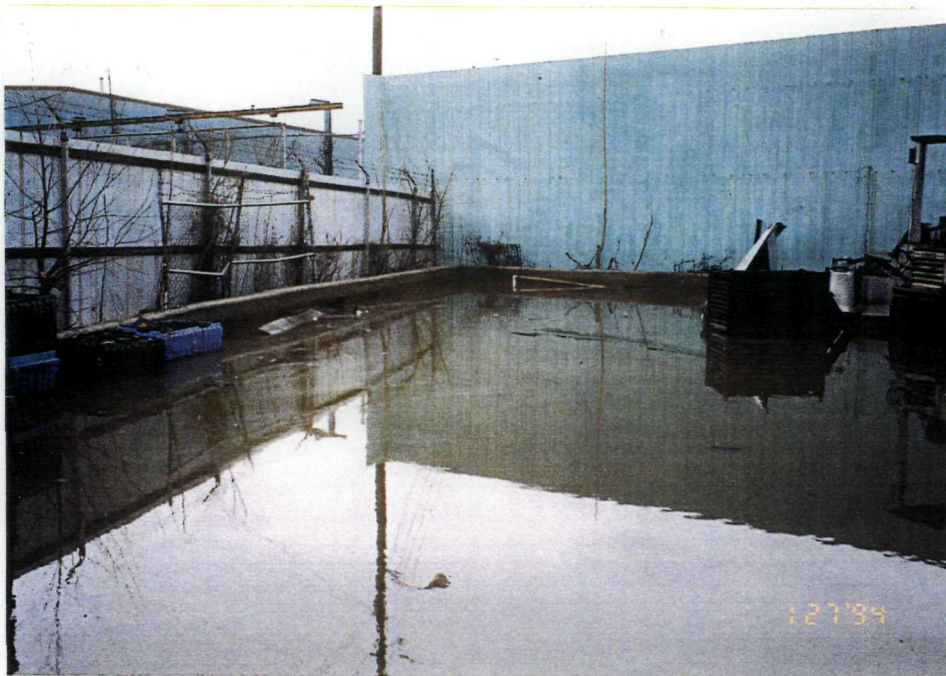
Photograph No. 8

Description: Concrete dike containing storm water at southeast corner of the facility; note small pipe in center used to pump wastewater to Wastewater Treatment System (SWMU 5)

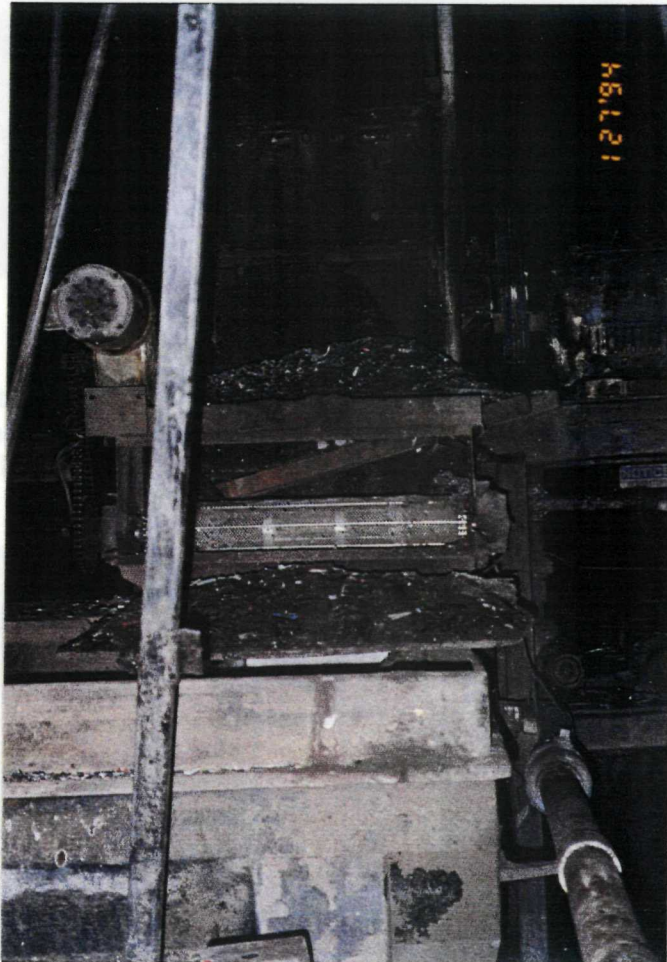
Location: SWMU 6  
Date: 01/27/94

Photograph No. 10  
Orientation: West  
Description: Grinder mechanism of MA Separator

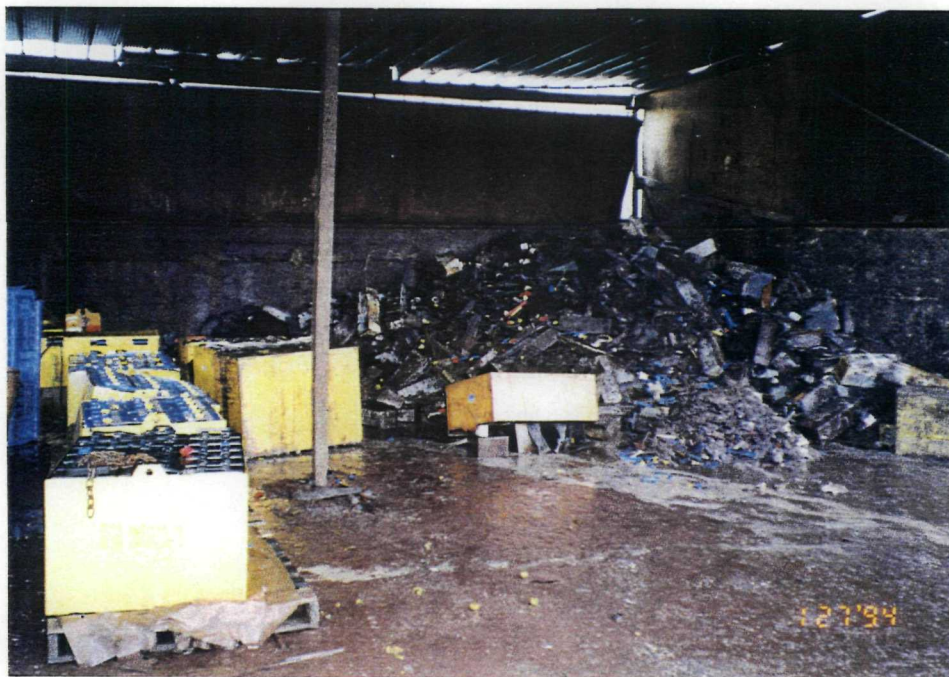
Photograph No. 13

Description: Industrial Lead Storage Yard; note large, overturned battery being drained

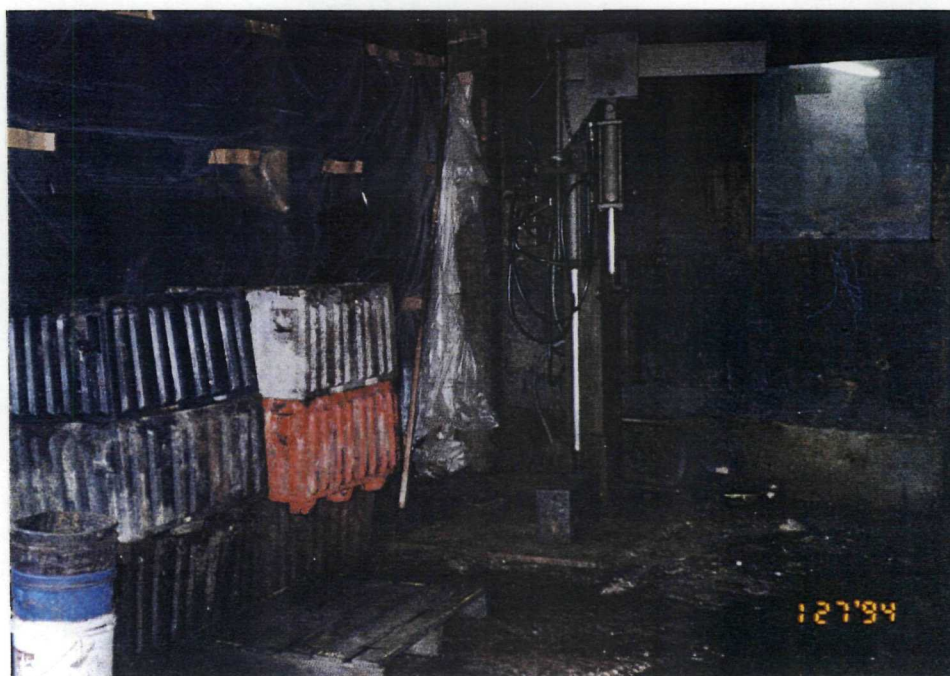
Photograph No. 14

Description: Hydraulic chisel (can opener) used to open metal-cased industrial batteries

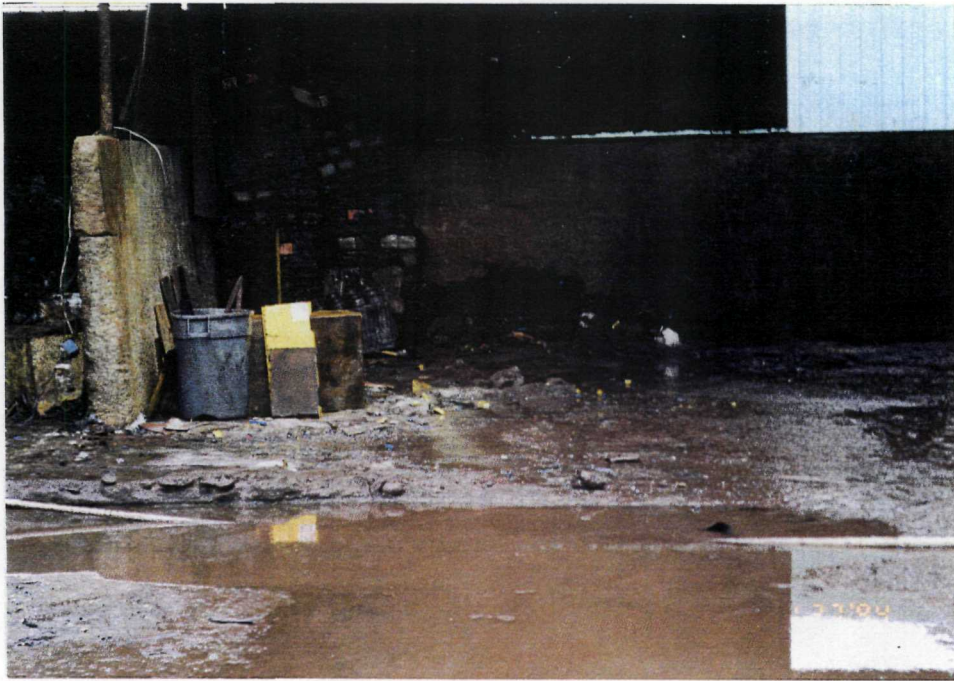
Location: SWMU 8  
 Date: 01/27/94

Photograph No. 15  
 Orientation: West  
 Description: Nonindustrial Lead Storage Yard

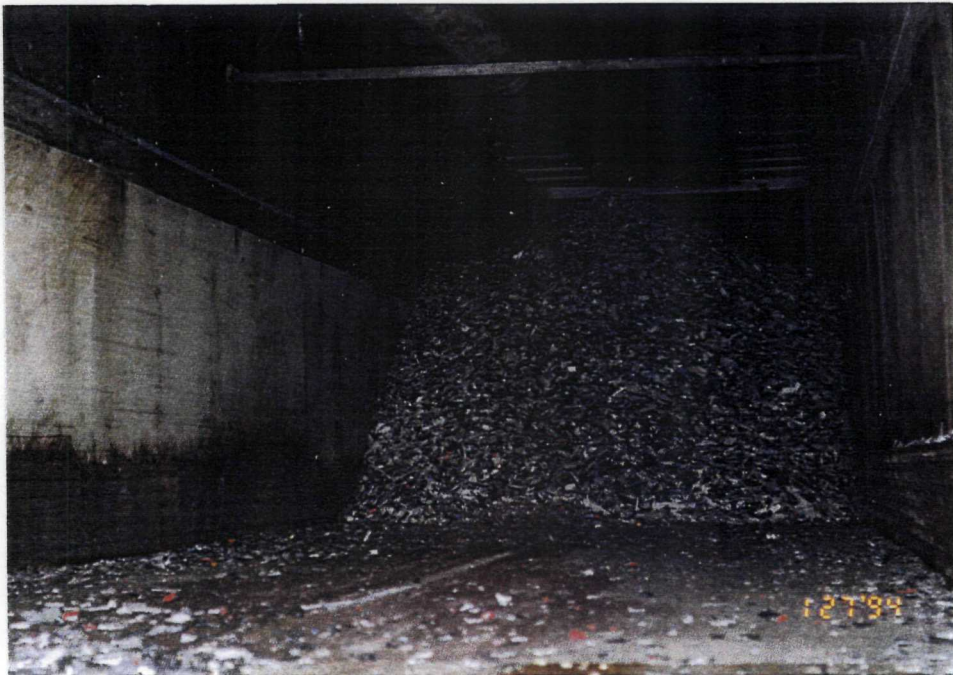
Location: SWMU 9  
 Date: 01/27/94

Photograph No. 16  
 Orientation: East  
 Description: Transport trailer partially filled with washed polypropylene

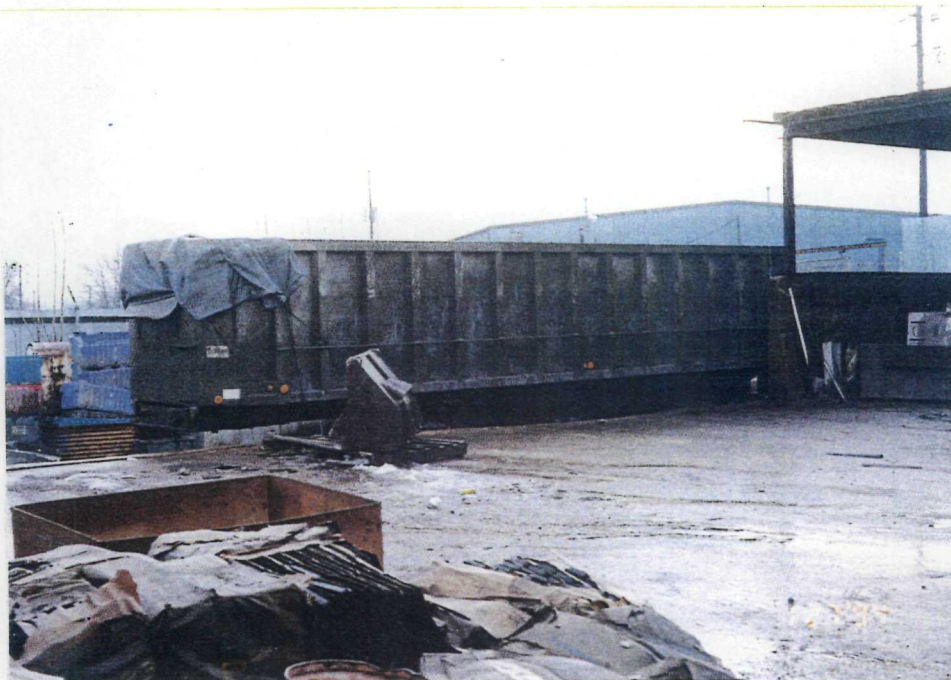
During the VSI, the trailer was about one-third full of washed polypropylene. Some polypropylene fragments were observed on the ground surrounding the trailer, and the pavement was wet from the recent rains. No uncontrolled releases were observed at this unit. Photograph No. 16 shows the partially filled trailer at this unit.

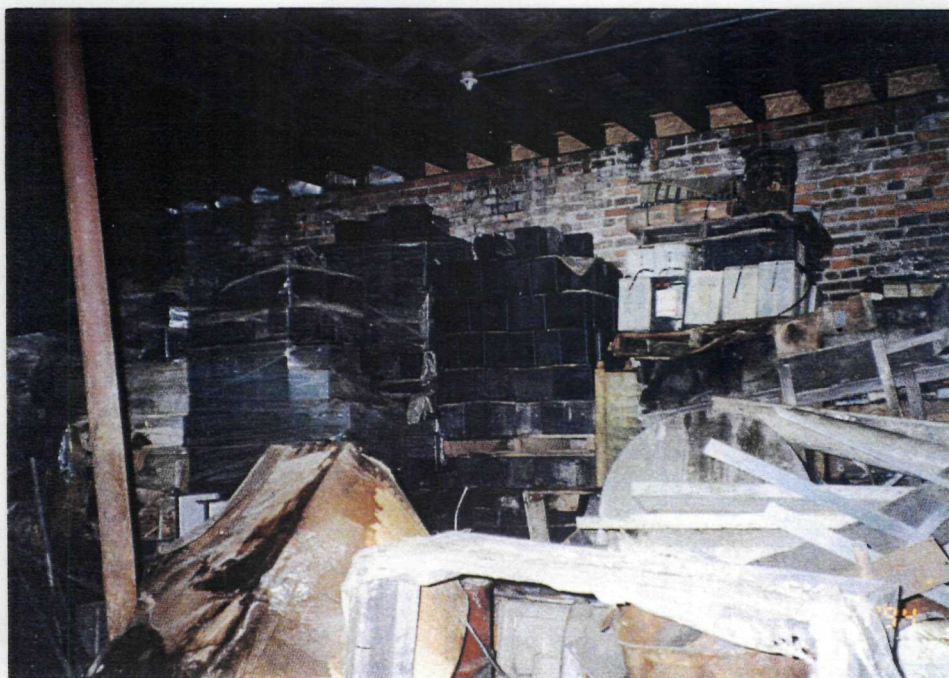
**Observations:** The content of the trailer were not observed during the VSI because of the height of the trailer. ACE representatives indicated that normal operations generate three to four trailer loads of waste each day. No evidence of release was observed, nor were there any visible structural cracks in the concrete paving surrounding the unit. Photograph No. 17 shows the unit in relation to the south portion of the facility.
